UNDERWATER BRIDGE INSPECTION REPORT

STRUCTURE NO. 60506

RED RIVER OF THE NORTH

MINNESOTA DEPARTMENT OF TRANSPORTATION
UNDERWATER BRIDGE INSPECTION

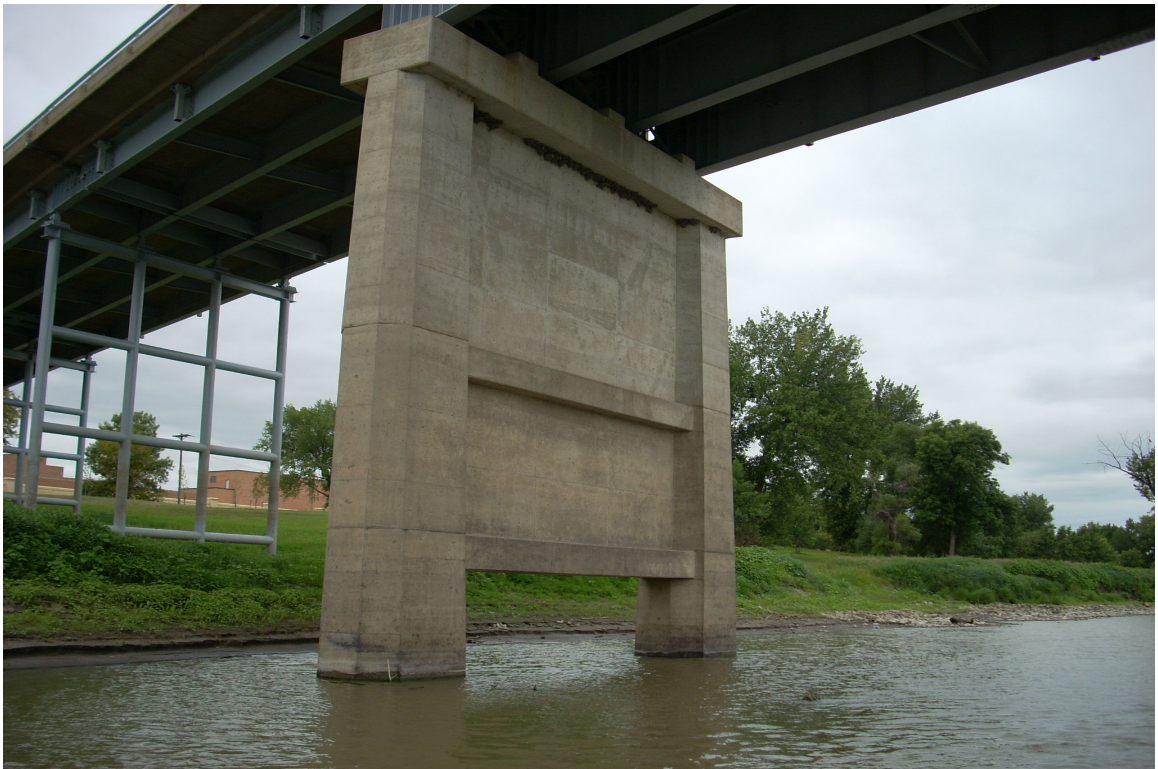
Photograph 2. View of Pier 6, Looking Northwest.

- 3 The channel bottom consisted of sandy silt with up to 1 foot of probe rod penetration.
- 4 A light accumulation of timber debris, consisting of 6 inch diameter branches, was observed at the upstream end of Pier 6 and extended from the channel bottom to the waterline. The accumulation was 10 feet long (E-W) and 3 feet wide (N-S).

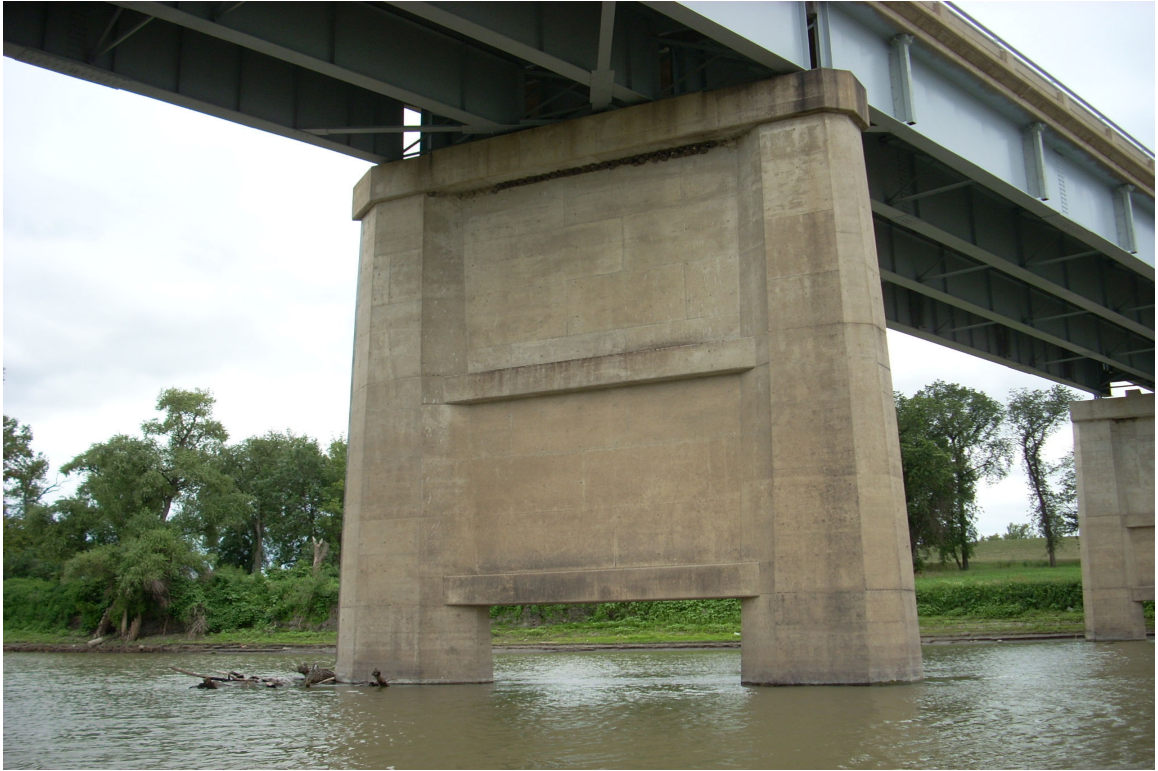
Photograph 3. View of Pier 7, Looking Southwest.

- 5 A moderate to heavy accumulation of timber debris, consisting of 1 to 2 foot diameter logs, was observed around the entire perimeter of upstream column of Pier 7. The debris extended from channel bottom up to 1 foot above waterline and approximately 8 feet out away from the pier column faces.

- 6 Both riverbanks of the channel exhibited moderate erosion.
- 7 A moderate accumulation of timber debris consisting of 1 foot diameter and smaller logs and branches was observed around the entire perimeter of downstream column of Pier 7. The debris extended from channel bottom up 6 feet and up to 6 feet off the column faces.

Remove the accumulations of timber debris from around Pier 7 during routine maintenance.

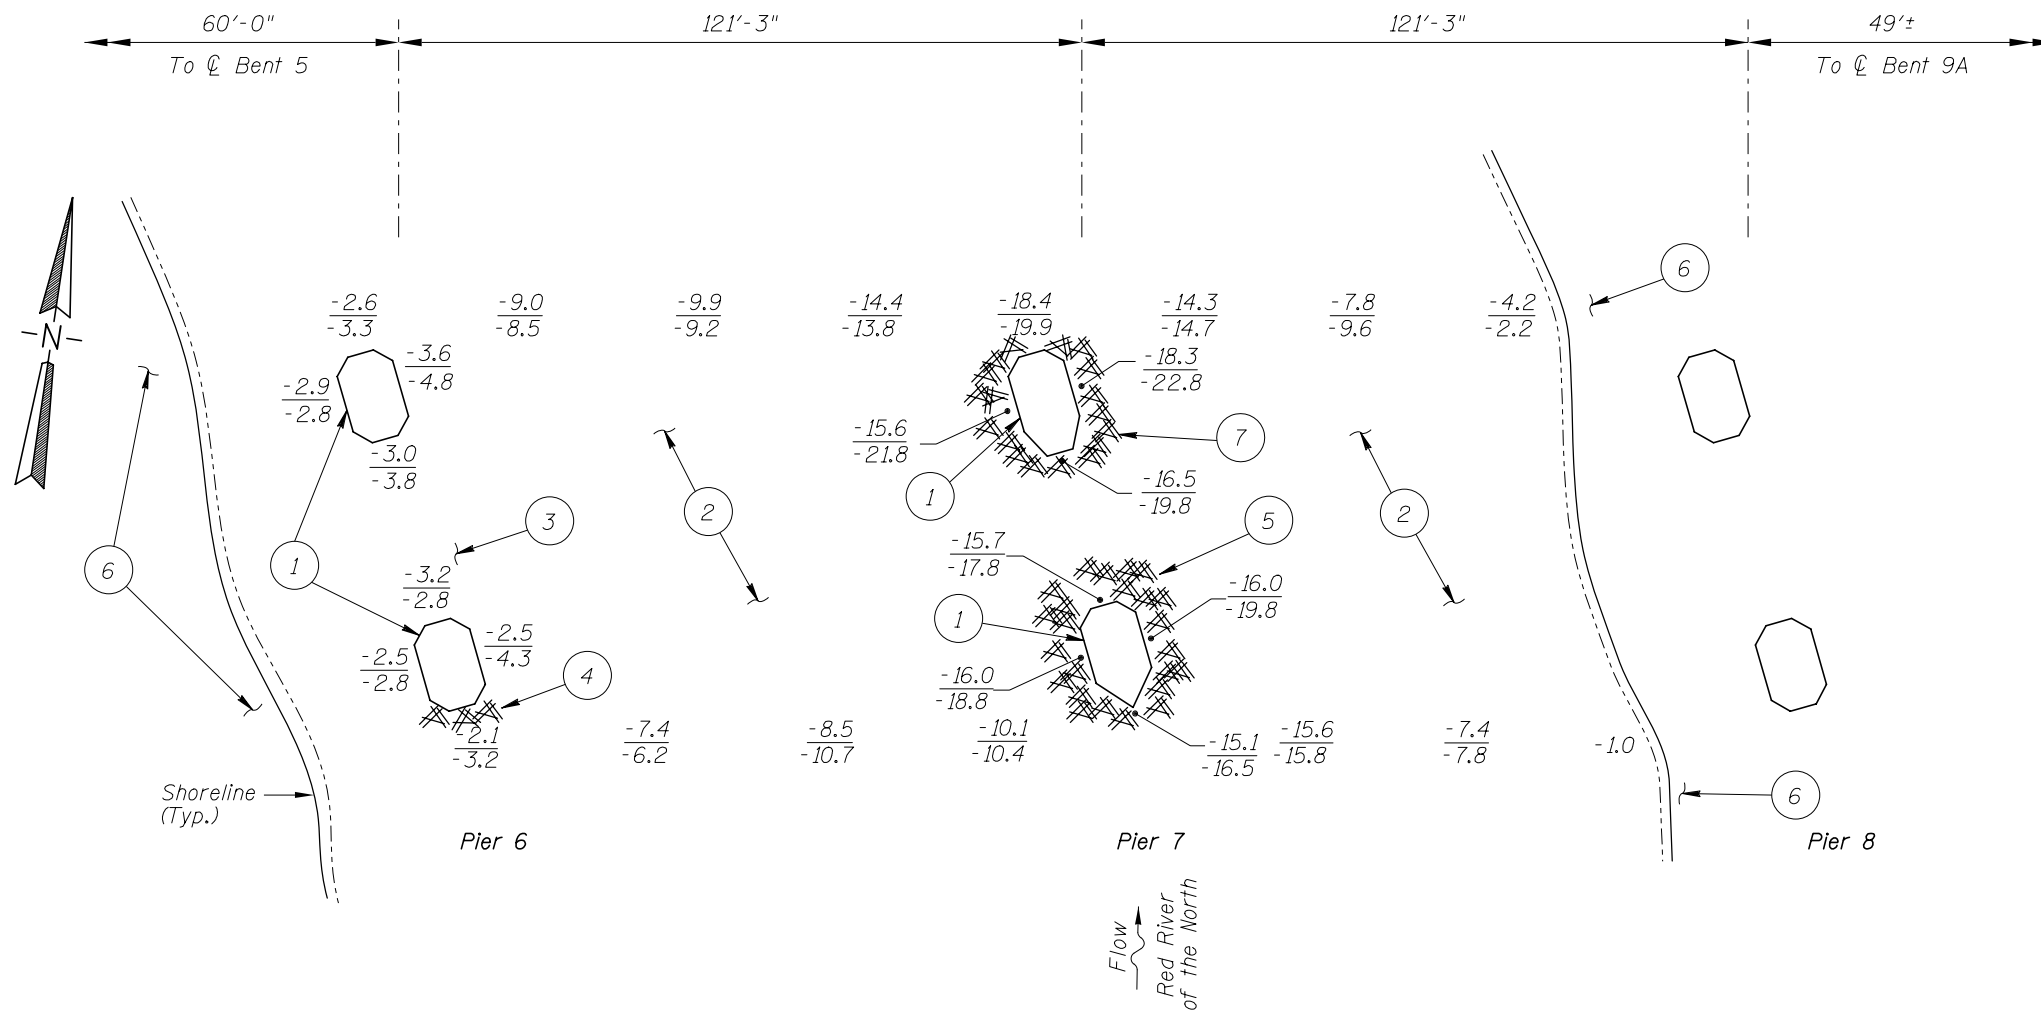
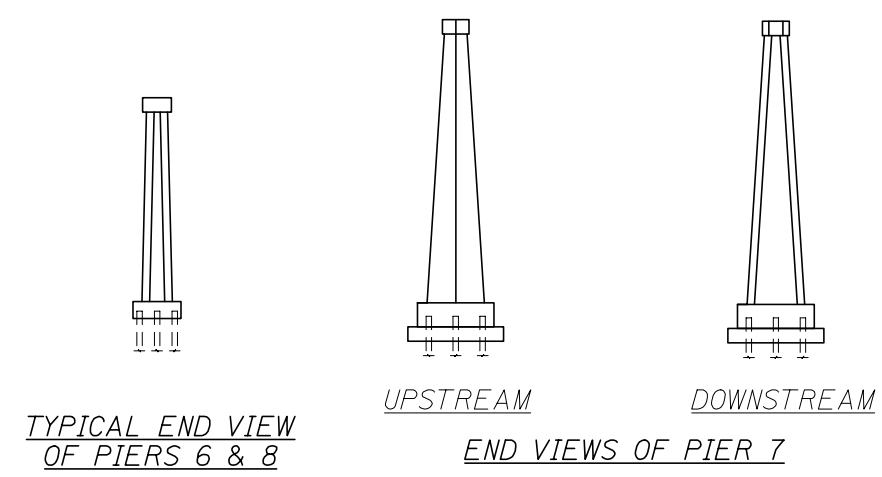
SOUNDING PLAN

- 1 Overall, the concrete of the piers was sound and smooth.
- 2 The channel bottom consisted of sandy clay with a probe rod penetration of up to 6 inches.

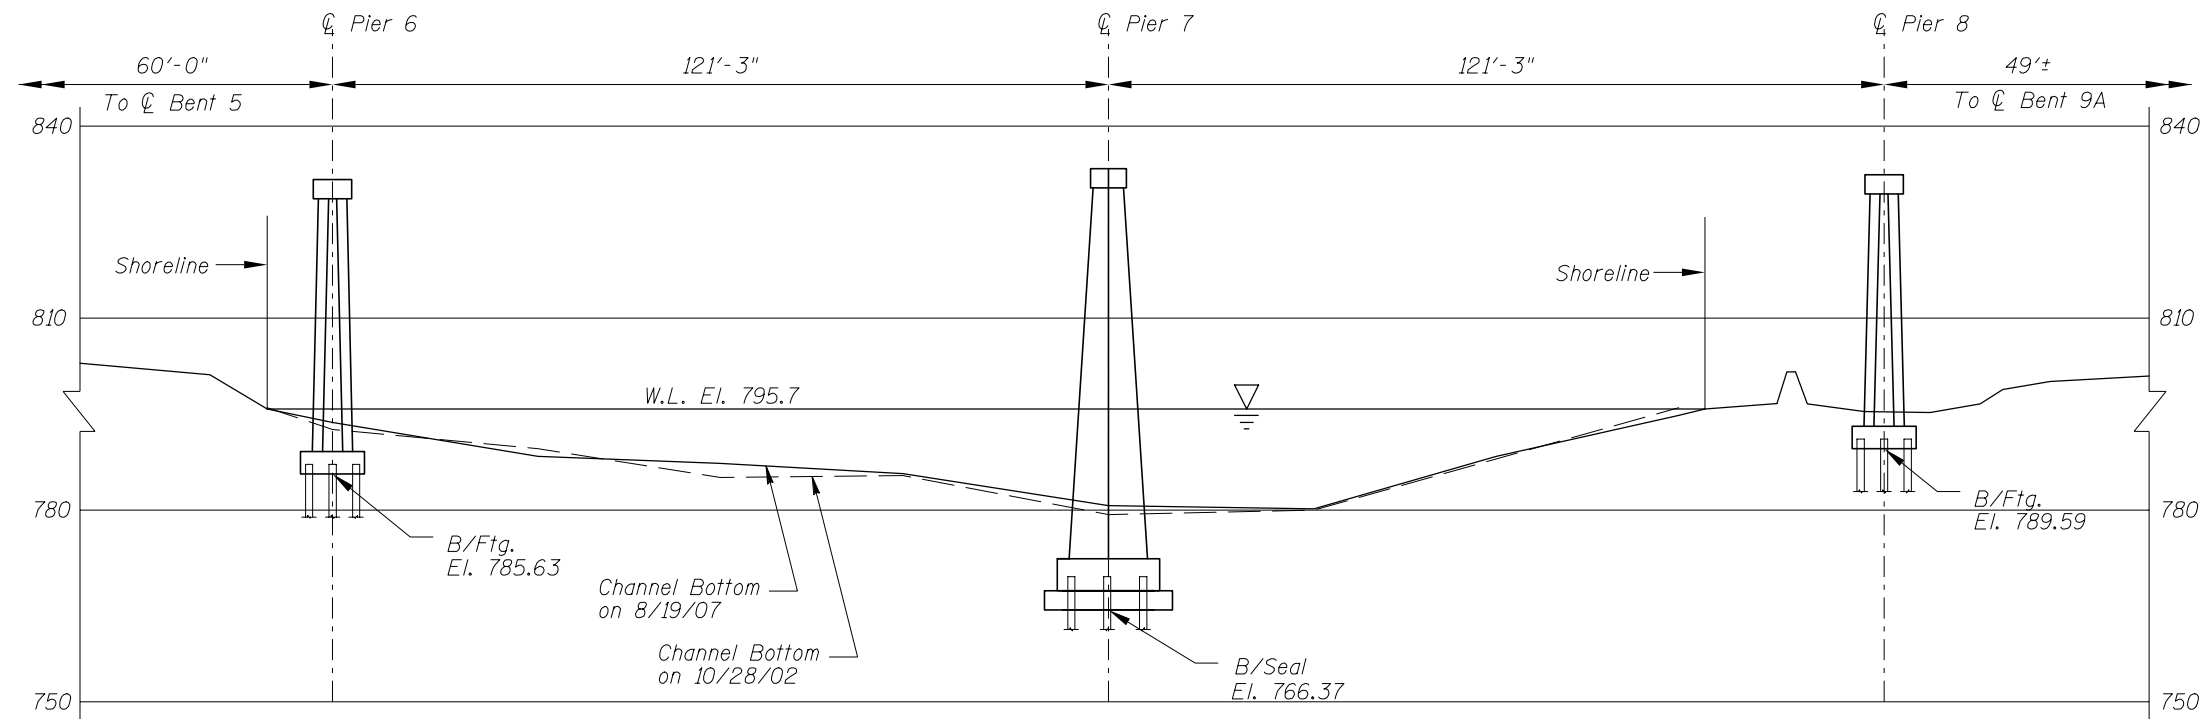
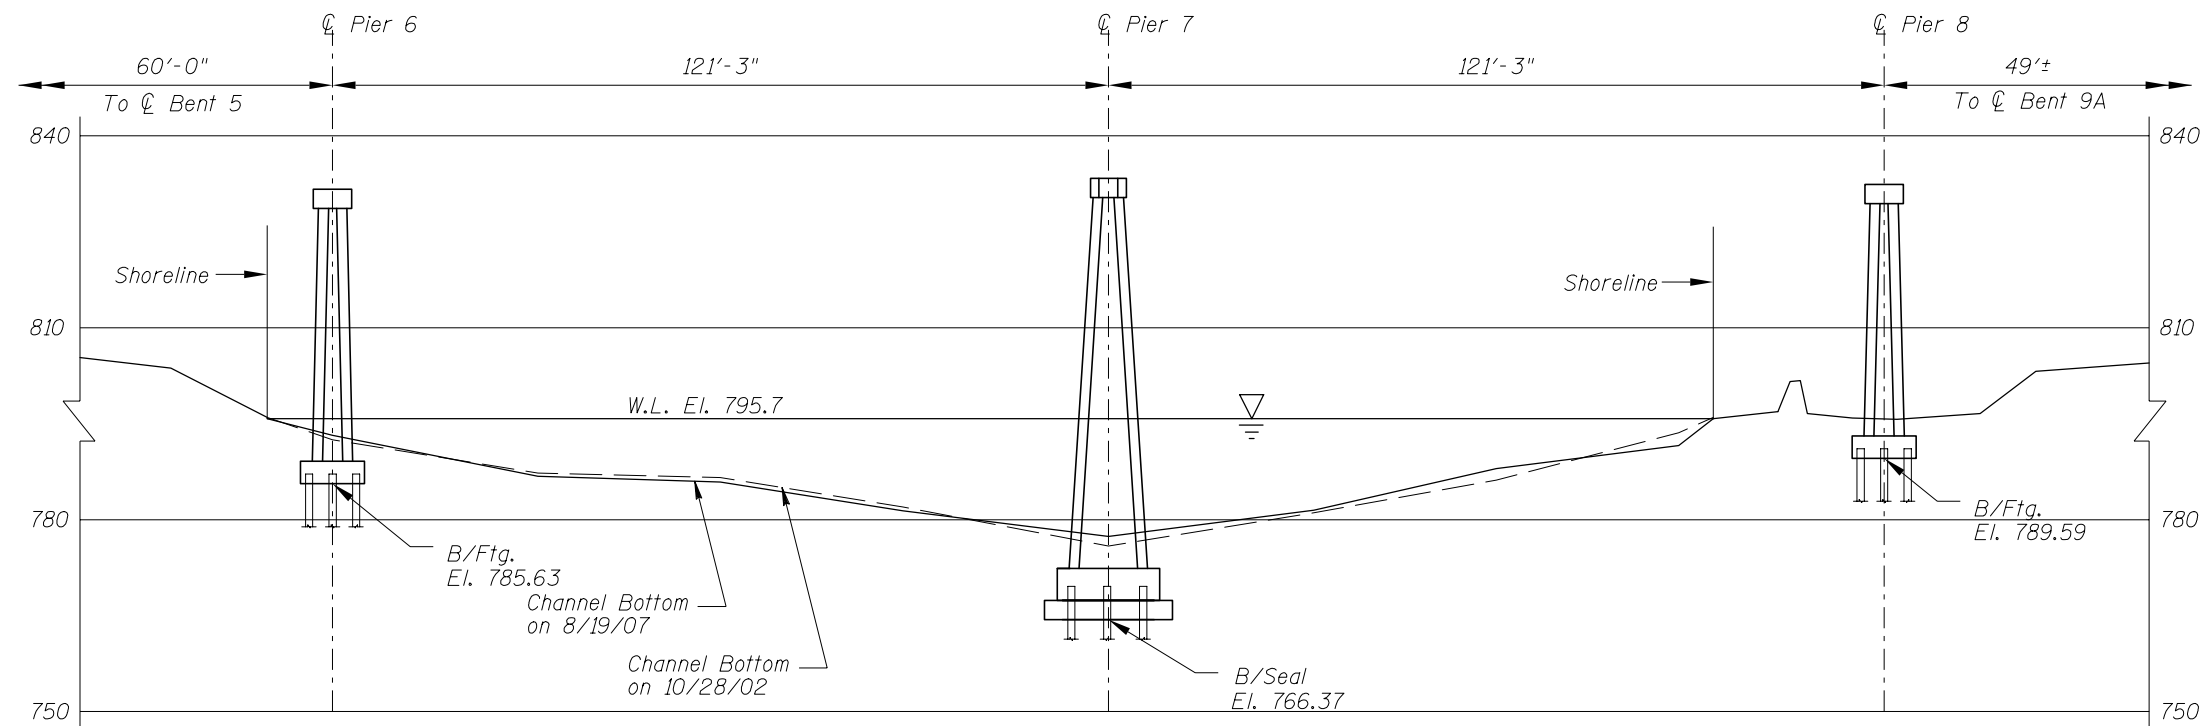
UPSTREAM FASCIA PROFILE

DOWNSTREAM FASCIA PROFILE
